Winter Stud Tyre Test Report

Glenn Billman
Mt Hotham Road Patrol
20/09/2017

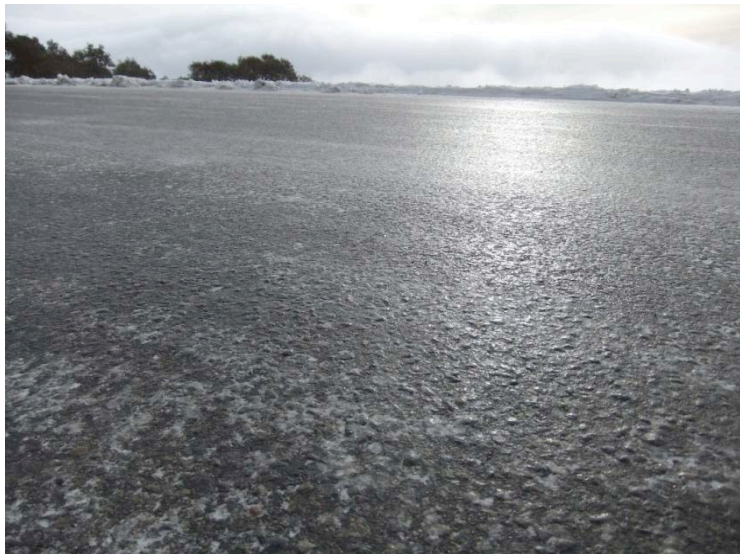
This section of road is fully sealed and passes through the Mt Hotham Village and Dinner Plain; the road rises to an altitude of 1,840 metres and is subjected to considerable snowfalls, blizzards and high winds. This section of the Great Alpine Road also regularly experiences the formation of Black Ice. Black Ice is formed by a thin layer of water freezing on the surface of the road and has the appearance of a wet road.

Black Ice.

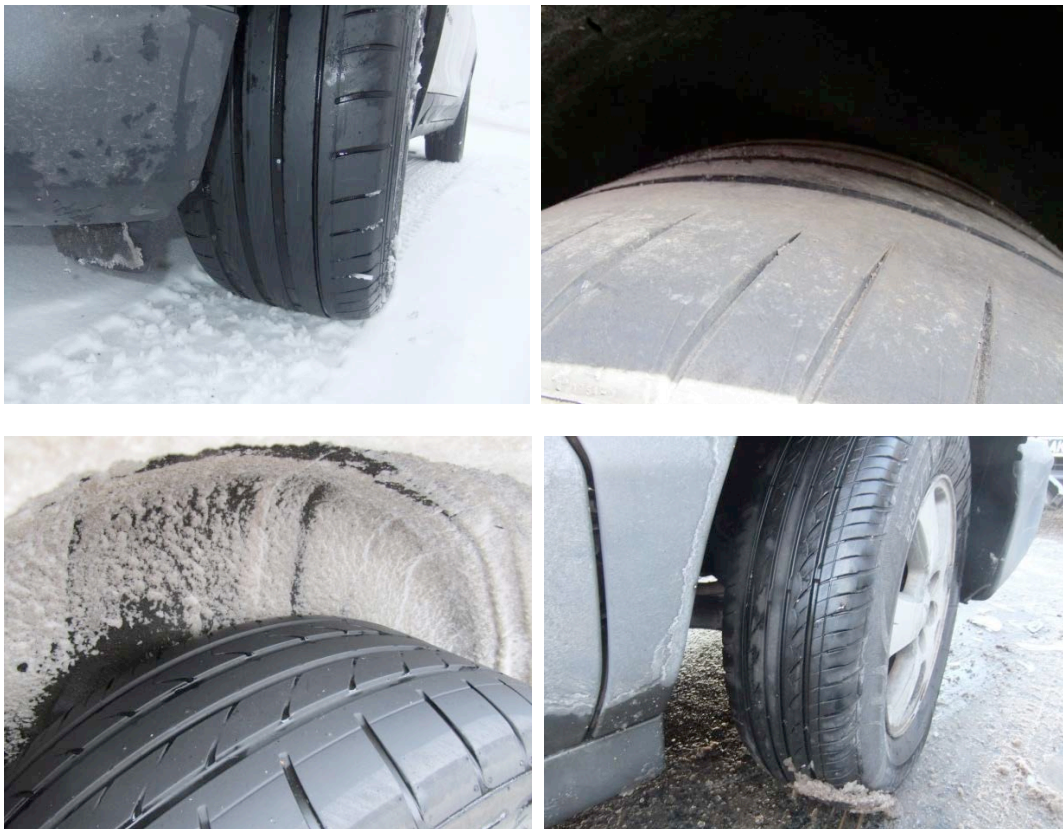
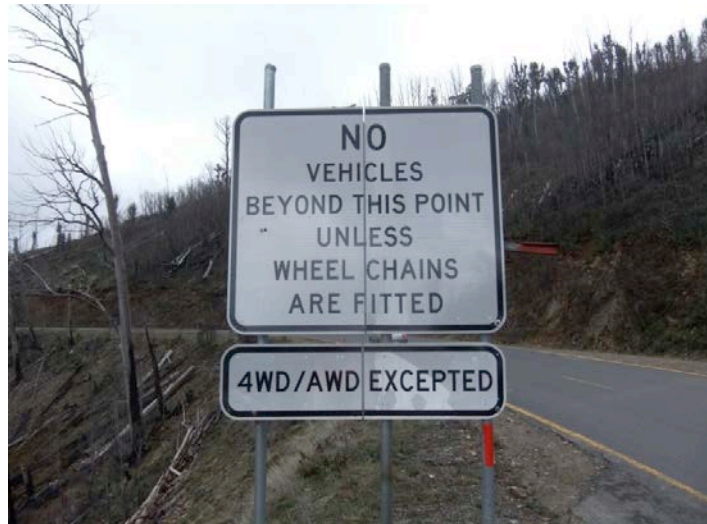
The photographs on page 5 are of four different AWD and 4WD vehicles fitted with road worthy highway tyres. Three of the four vehicles were involved in road incidents requiring the vehicles to be towed from the Mountain the other one was parked in a mountain car park. All four vehicles had less than suitable tyres for snow and ice conditions and none of the above vehicles were at the time, by law required to fit wheel chains. To help overcome the lack of traction issue, drivers are instructed to fit wheel chains by the Authorities. This decision is categorised by the type of drive system the vehicle employs and not the traction capabilities the tyres.

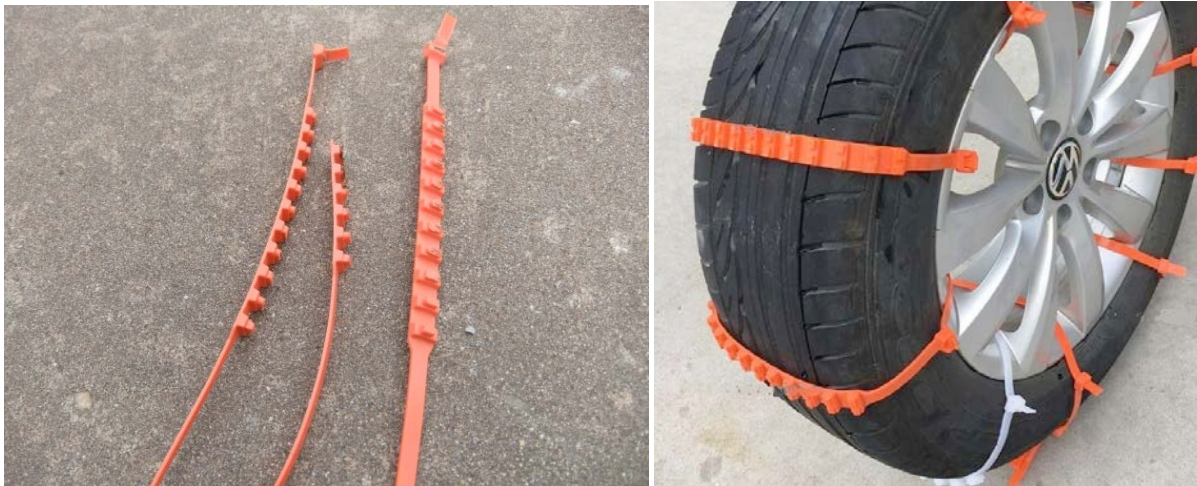
The above photos are of a traction device removed from a vehicle in 2017 at Mt Hotham. This is a device that is currently being advertised on the internet and is nothing more than a plastic cable tie with knobs on it to serve as cleats. It is fitted to the wheel by placing each one through the wheel and pulling it tight. This product is not suitable for Australian alpine conditions or legal under Victorian regulations and must not be used.

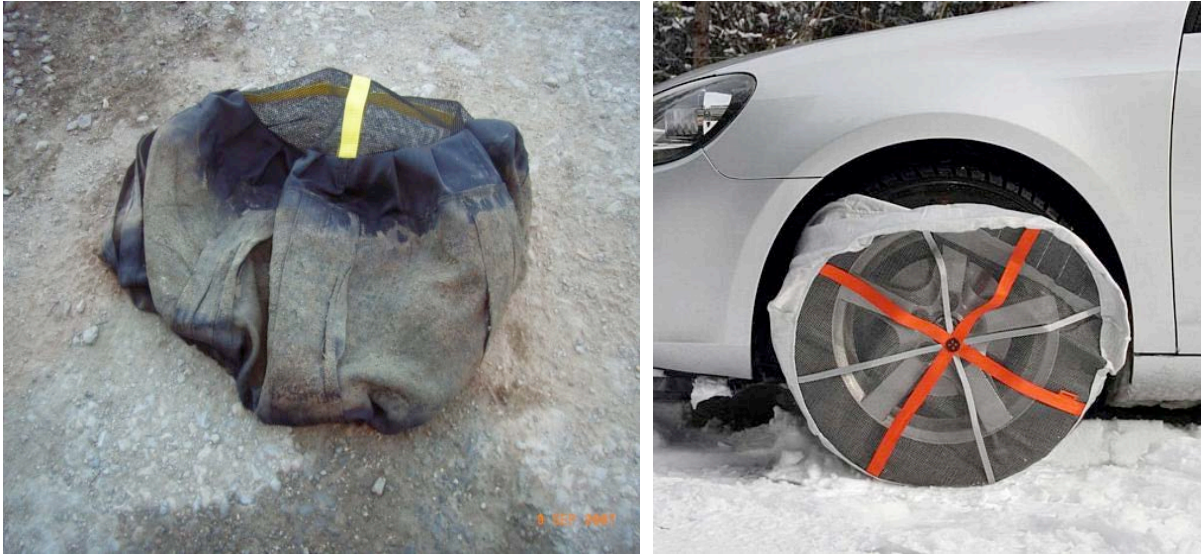
The above photos are of traction device called the Snow Glove or another name for a similar product is Snow Sock. These items fit over the drive wheels of the vehicle a little like fitting a shower cap. The product in the left photo was tested in the past at Mt Hotham under Vic Roads regulations. It was made from a cloth based material and began to disintegrate after approximately 4km of normal road travel.

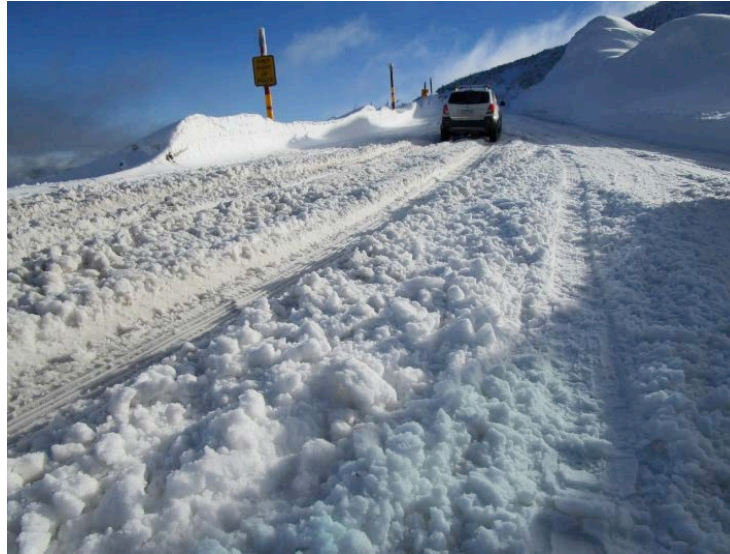
The above photo is of deep compacted snow churned up by excessive wheel spin on an uphill section of the road.

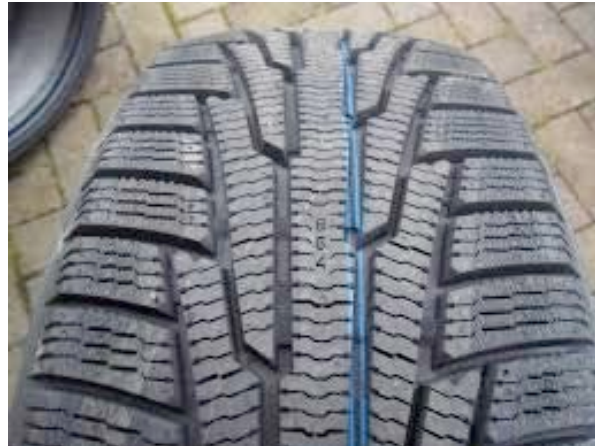
Winter Tyres (also known as Snow Tyres) have deeper tread patterns specifically designed to compact and grip on to snow to provide traction. Winter tyres are made from a softer rubber compound compared to other types of tyres on the market. This allows the winter tyre to retain flexibility in cold conditions and in conjunction with the many small serrated grooves known as sipes and sipe activators provide extra traction in snow and icy conditions compared to Highway and All Terrain tyres commonly fitted to vehicles today. The wider sipe activators located on the side of the tyre assists in opening the narrower ones thus providing traction with the snow.

Winter Tyre

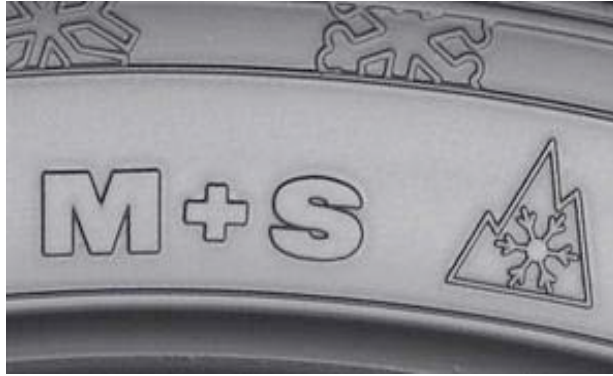
Winter tyres are designed and manufactured specifically for snow and ice and can provide enhanced braking performance in snow and icy conditions compared to other types of tyres. They perform well in all types of winter conditions including snow, ice, sleet, slush, wet and cold dry roads as well as roads covered with loose snow churned up by vehicles fitted with snow chains. The tread reduces snow build up and most drivers' experience an improved vehicle control and handling due to the aggressive tread and softer rubber compound used to manufacture the winter tyre, wheel chains also work more effectively when fitted to the winter tyres.

However while snow tyres are an excellent option for winter snow driving they should be removed from the vehicle at the end of each winter and replaced with suitable summer tyres. If stored correctly they can be refitted to the vehicle at the start of the following winter and the motorist should be able to achieve a good few winter seasons from a set of good quality winter tyres.

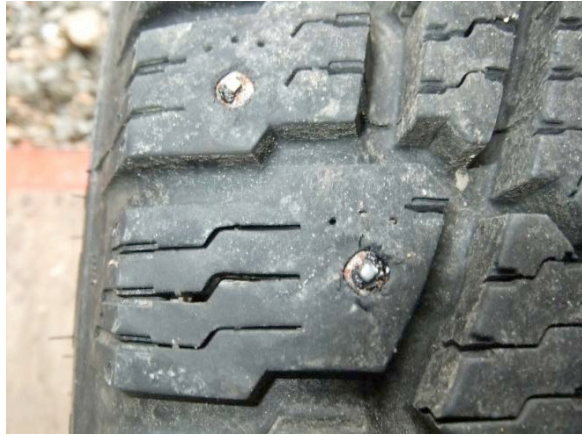
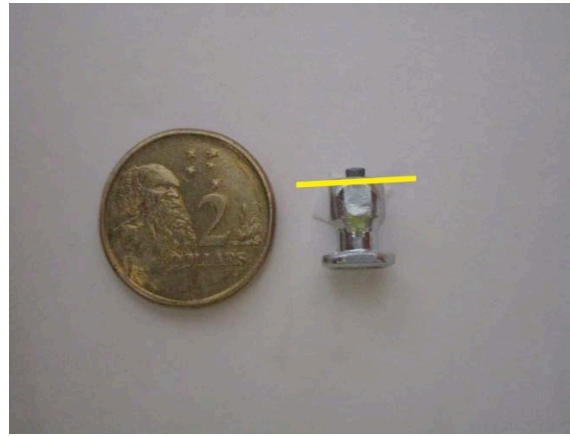
The photo on the left is of a winter studded tyre after its second season of operation and the photo on the right is of an actual stud. The section of the stud above the yellow line is what protrudes from the tyre surface to make contact with the surface of the road. The section of the stud below the yellow line is imbedded in to the tyre.

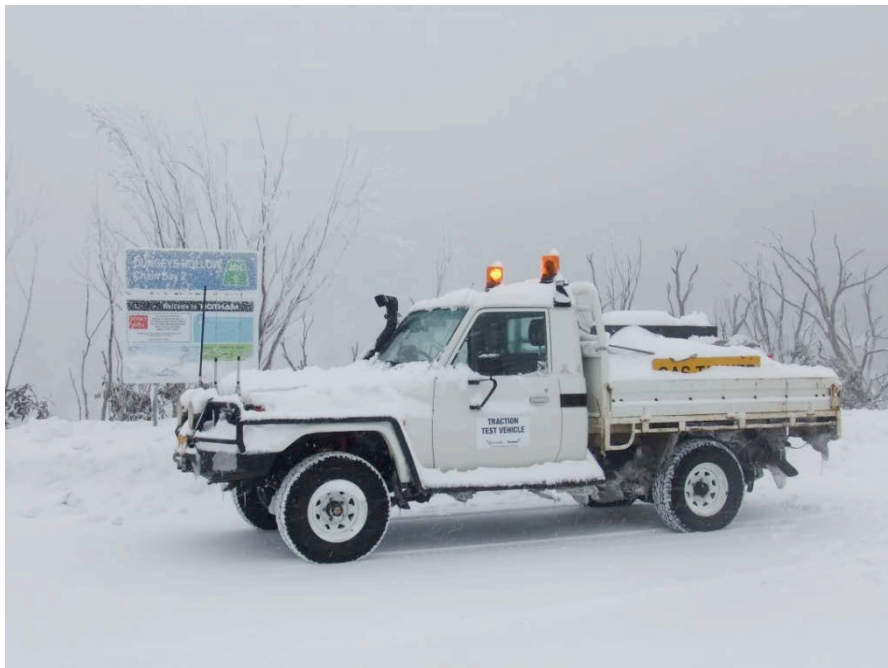
As mentioned in the introduction of this report the vehicle used for testing was a 2006 Toyota 4WD Landcruiser 6 cyl 4.2 turbo diesel steel tray utility. The approximate weight of this vehicle is 3000 kg with tools and equipment and the tyres fitted and tested in this report are Nokian Hakkapeliitta LT2 (Studded).
